A Case Study of an ISG Failure Using a Time Domain TVA

John Srodawa

Failure Description

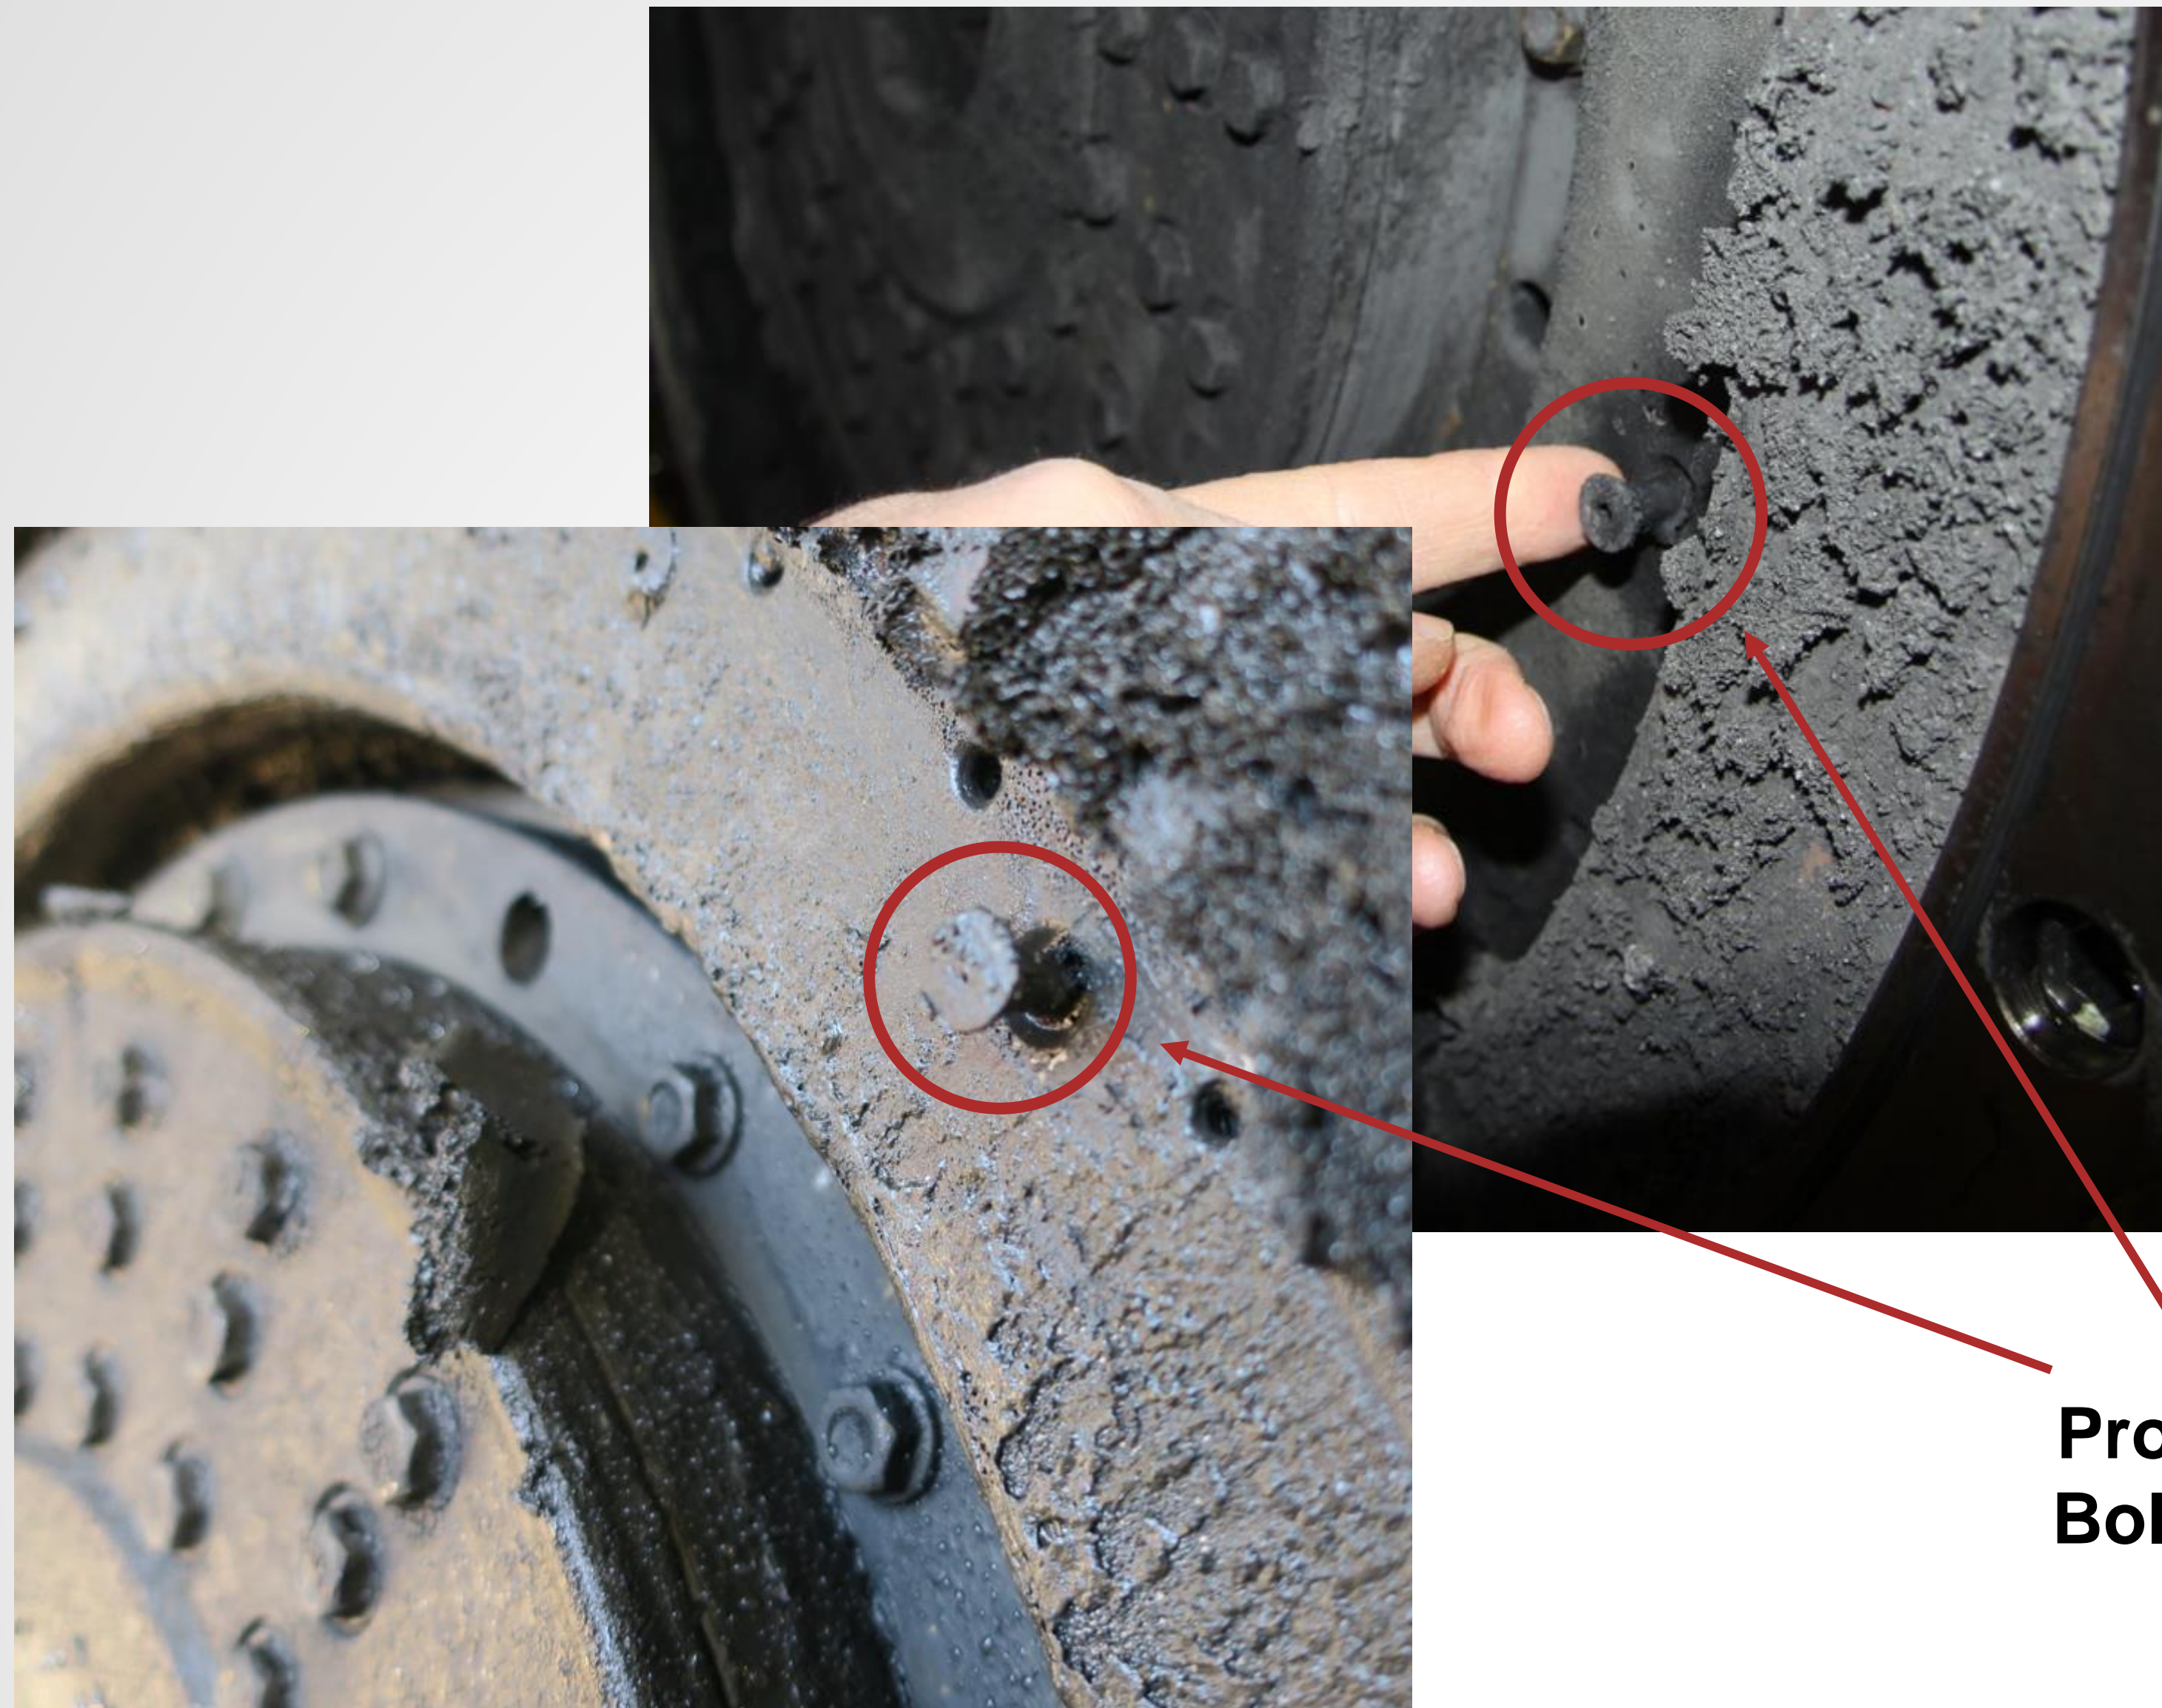
Nuts and Broken Bolts found in Debris

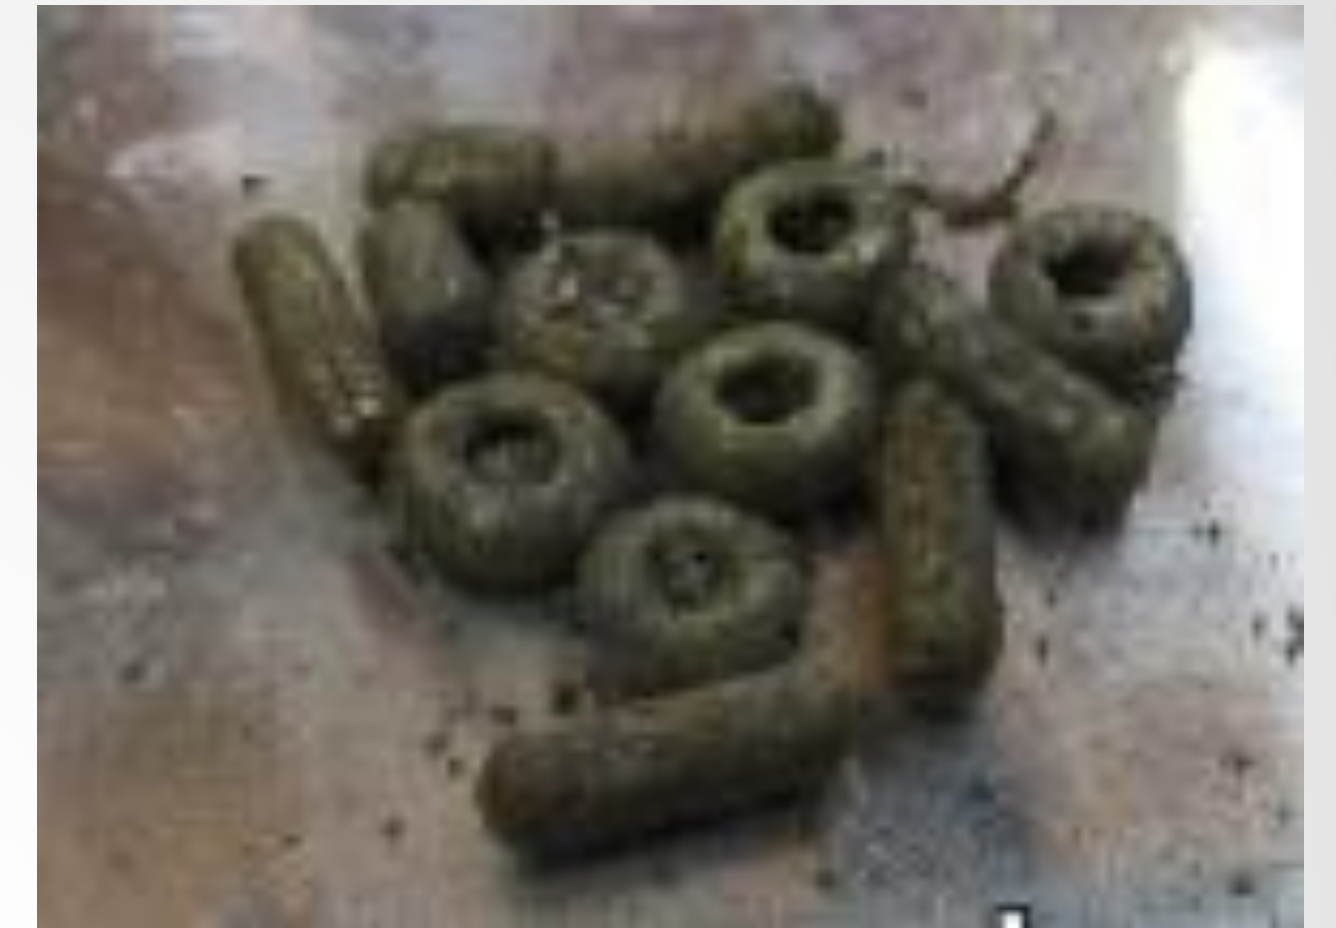
19 of 20 Rotor thru Bolts were found broken

Remaining thru Bolt was Loose

- **The bolted joint holding the rotor laminations together failed**
- **The loose screws and nuts became trapped between the rotor and the stator**
 - This led to broken coolant passages and electrical damage to the resolver and stator windings
 - Shorted stator windings led to a winding over temperature condition
 - Coolant leaking into the ISG air space was churned by the spinning rotor creating more heat
 - Damage to the coolant passages led to a loss of ISG cooling
- **Torsional vibrations became prime suspect since the ISG was tested extensively at the supplier under full load without any issues**

- **The time domain TVA model revealed the true torsional environment of the ISG rotor**
- **Based on these results, the ISG rotor was redesigned to meet an angular acceleration requirement of 1500 rad/s²**
- **The redesigned rotor has been exposed to over 500 miles of in-vehicle operation without issue**
 - More than 300 engine starts

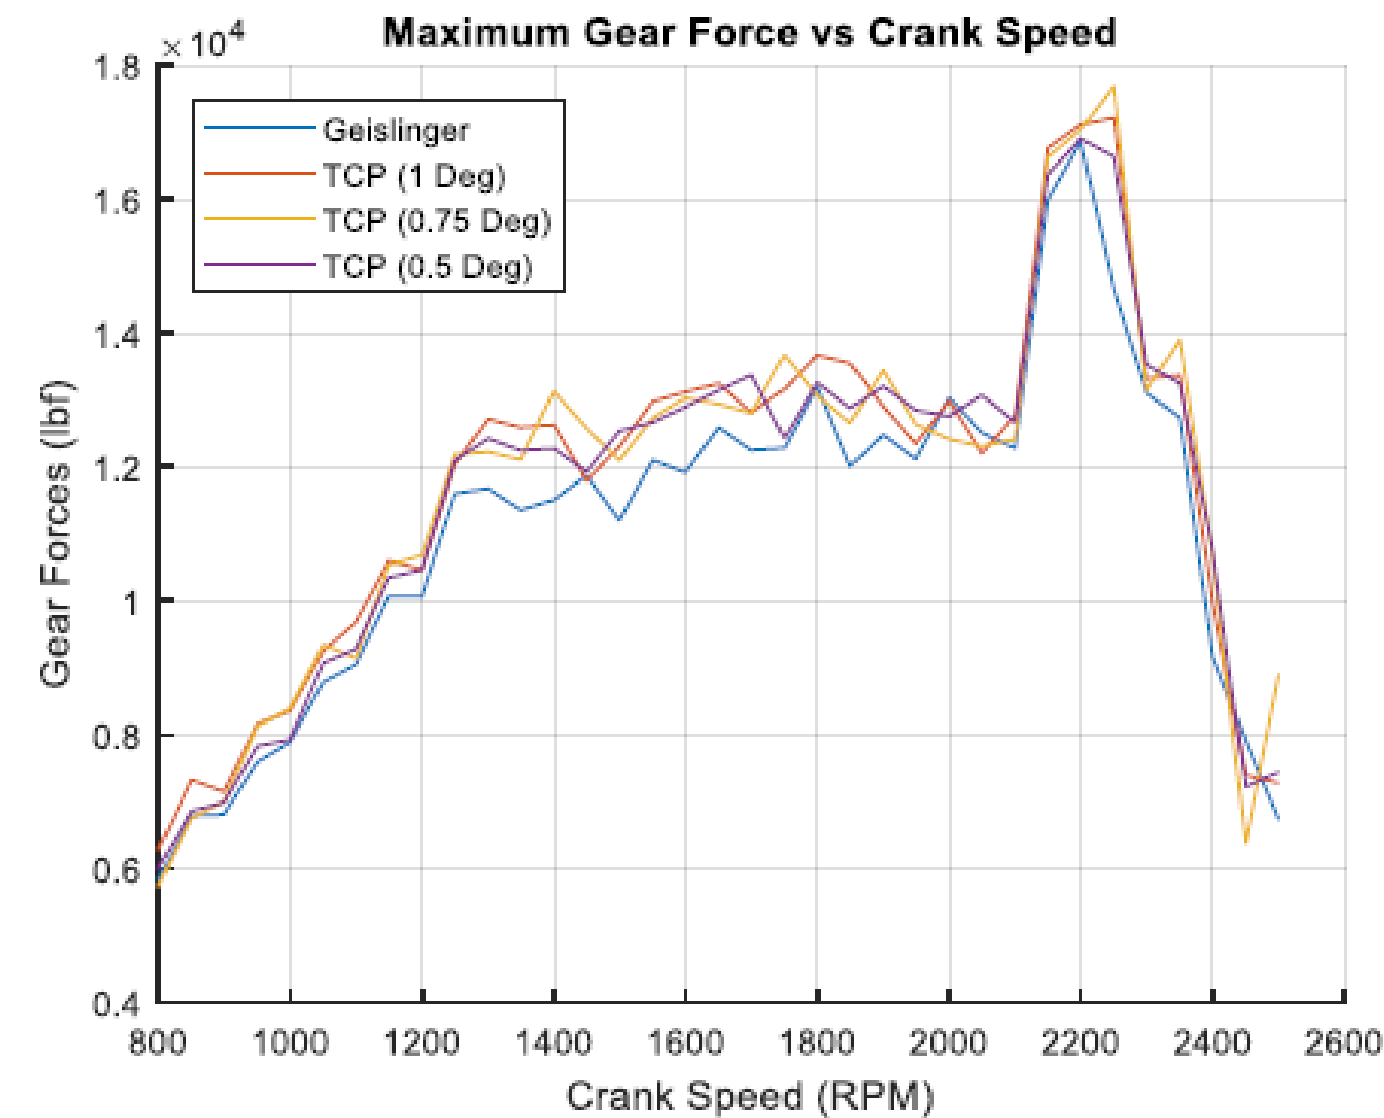
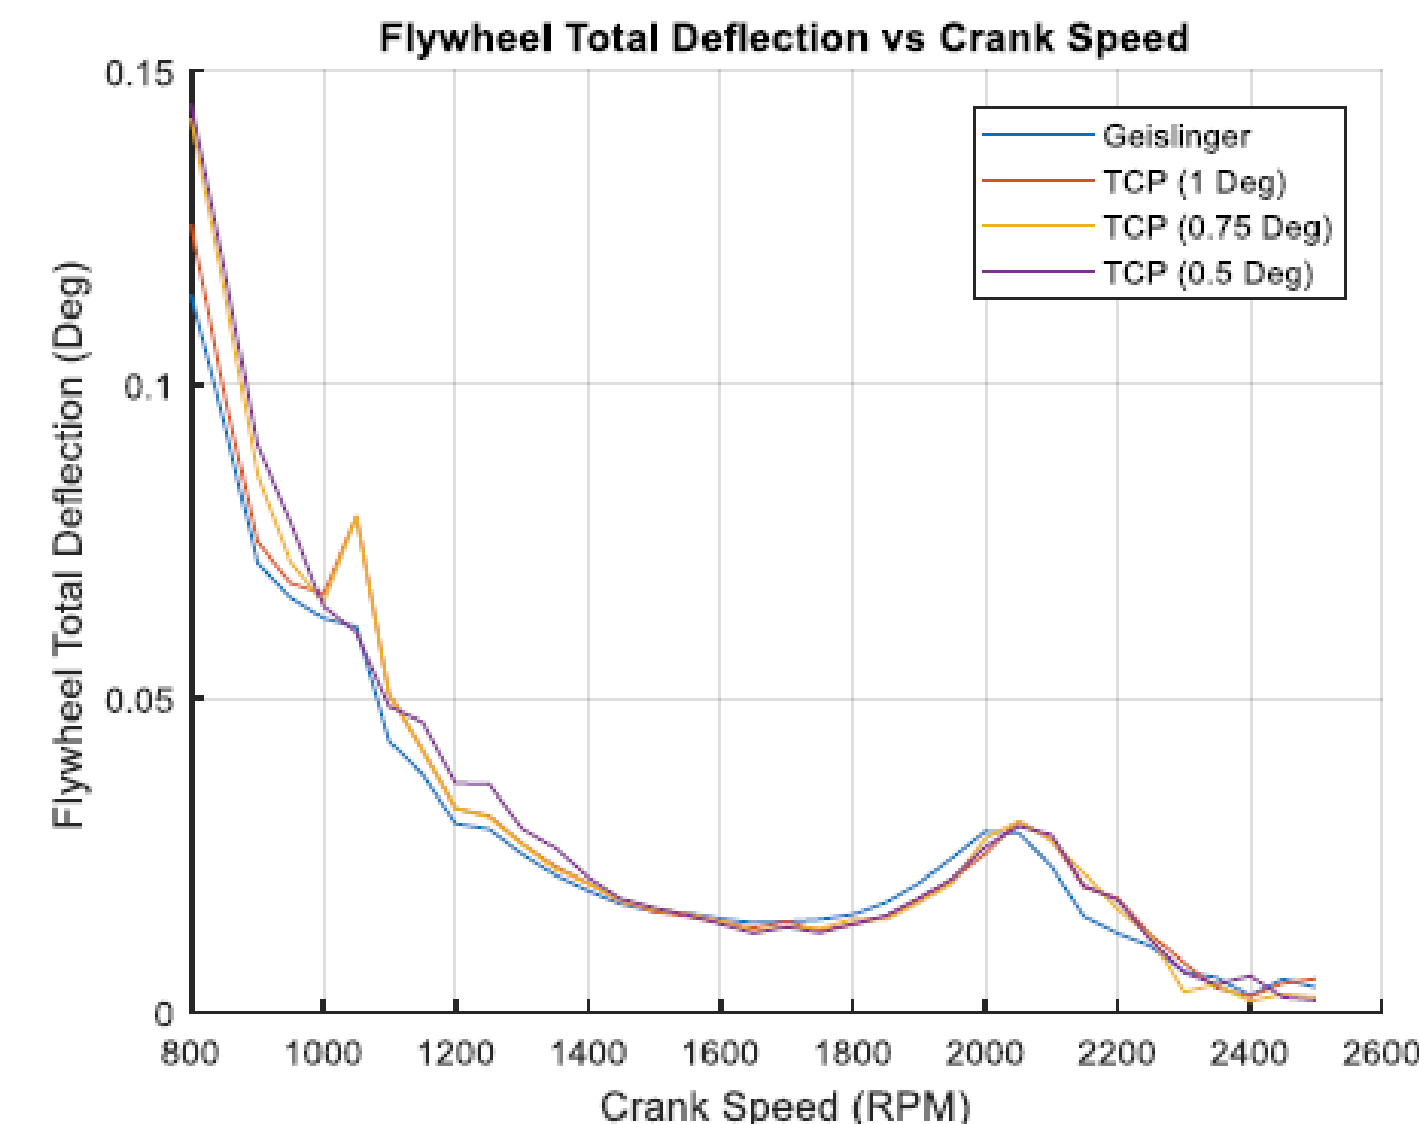
- Initial frequency domain torsional vibration analysis focused on the normal engine operating range
 - 800rpm to 2500rpm Crank
 - 900rpm to 2900rpm ISG
- The TVA was focused on engine gear train, crankshaft, and torsional coupling health
 - All design limits were met with margin
- Peak ISG deflection of 0.11 deg
 - This equates to $\sim 20 \text{ rad/s}^2$ at 26Hz
- There was no indication that the ISG would have issues

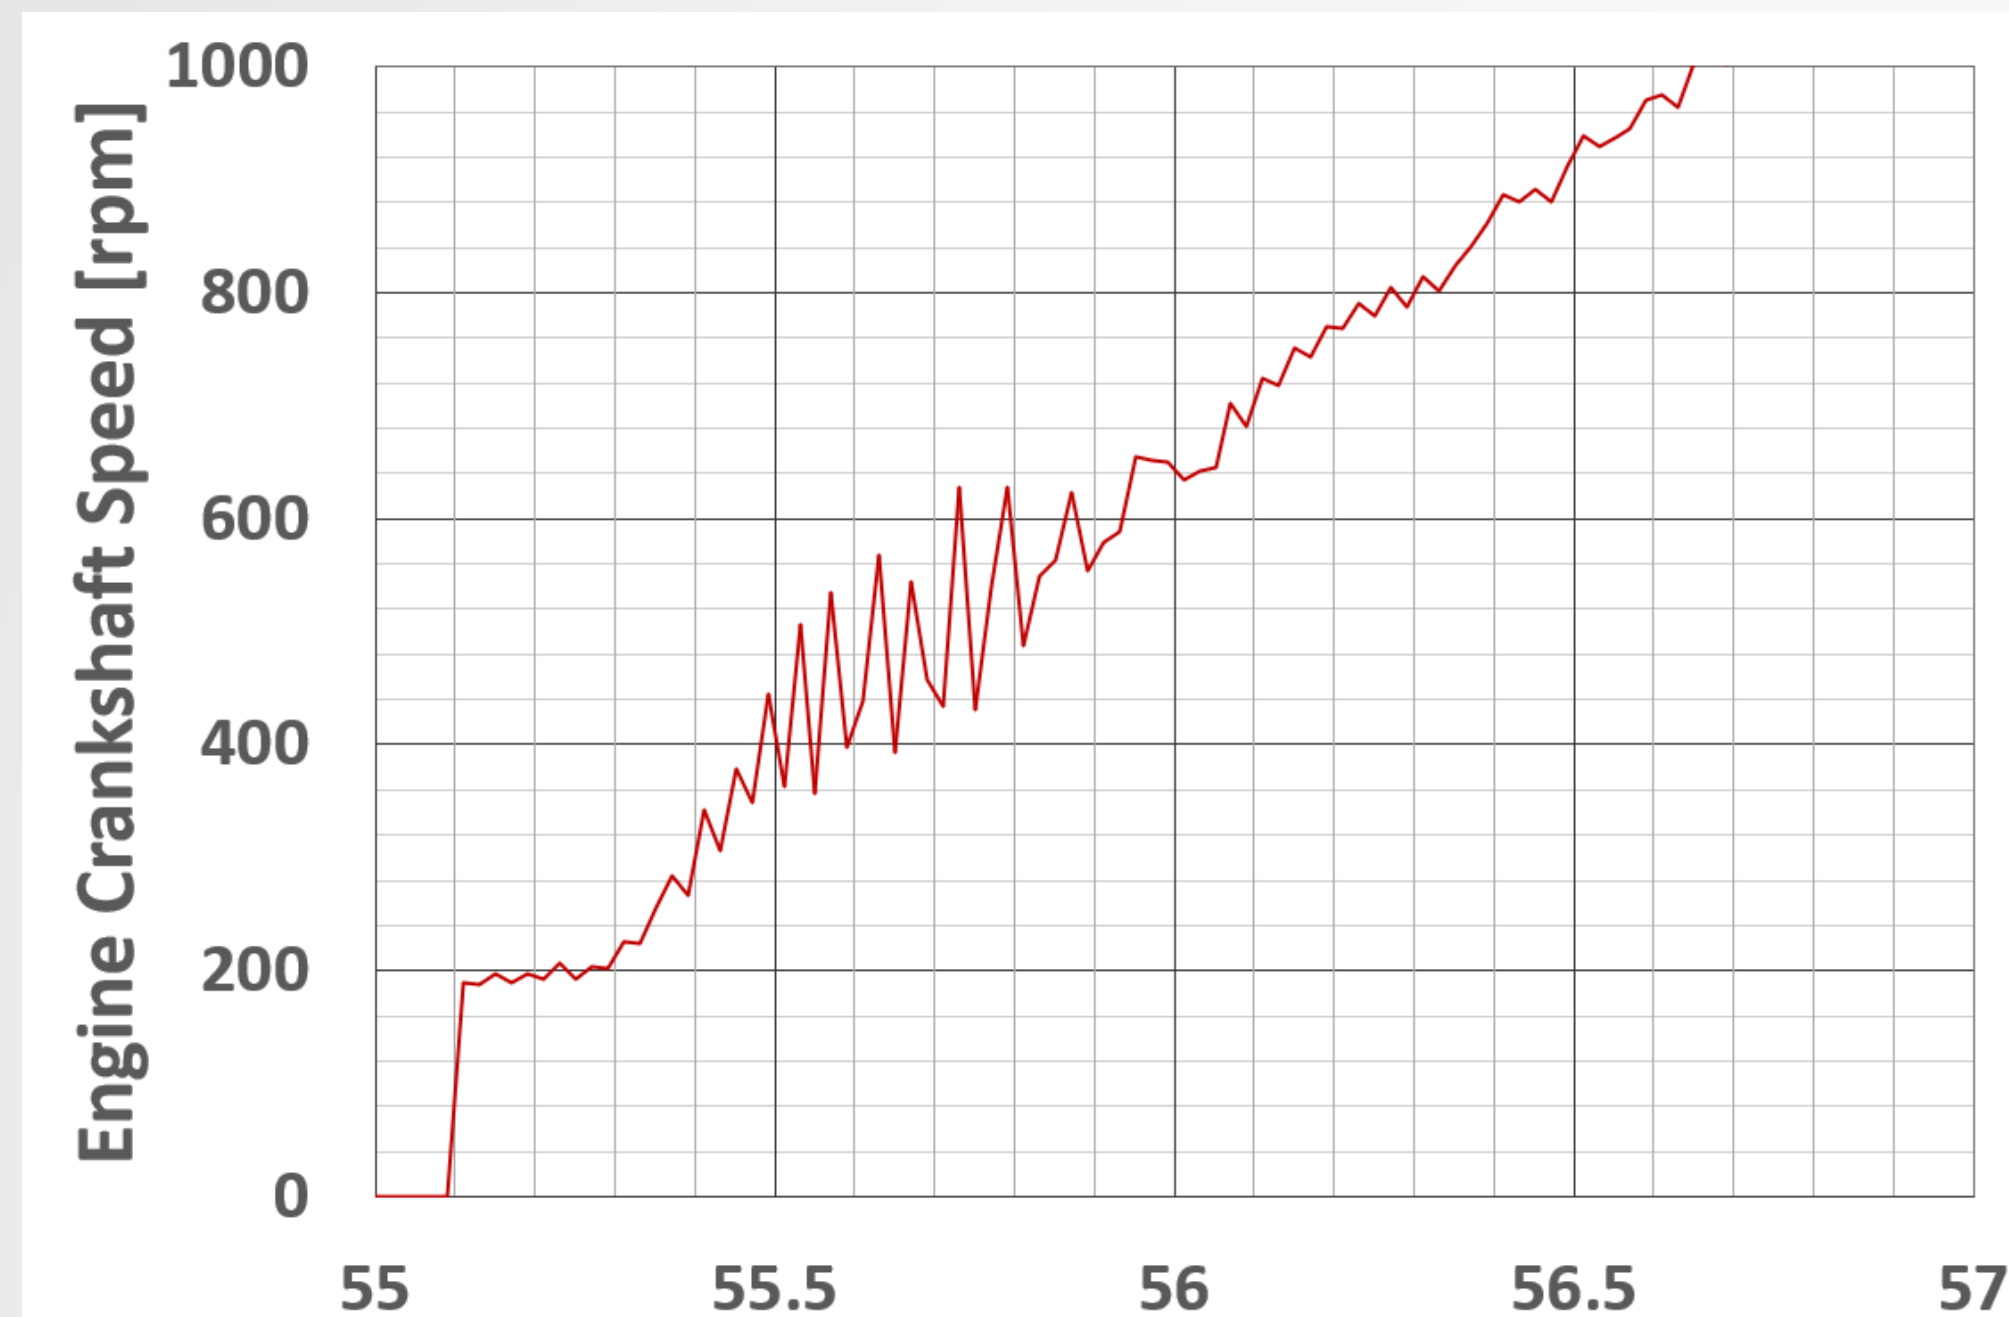
- Engine Speed Traces Recorded from CAN Bus at 50Hz Sample Rate

Time [sec]
Normal Engine Start

- **The amplitude of the vibrations and the number of cycles experienced during engine starting was surprising**
- **The CAN bus speed data shows limited fidelity due to the low sample rate**
 - Actual torsional behavior is likely more severe
- **This prompted the creation of a time domain torsional vibration model to obtain a better understanding of the torsional behavior**

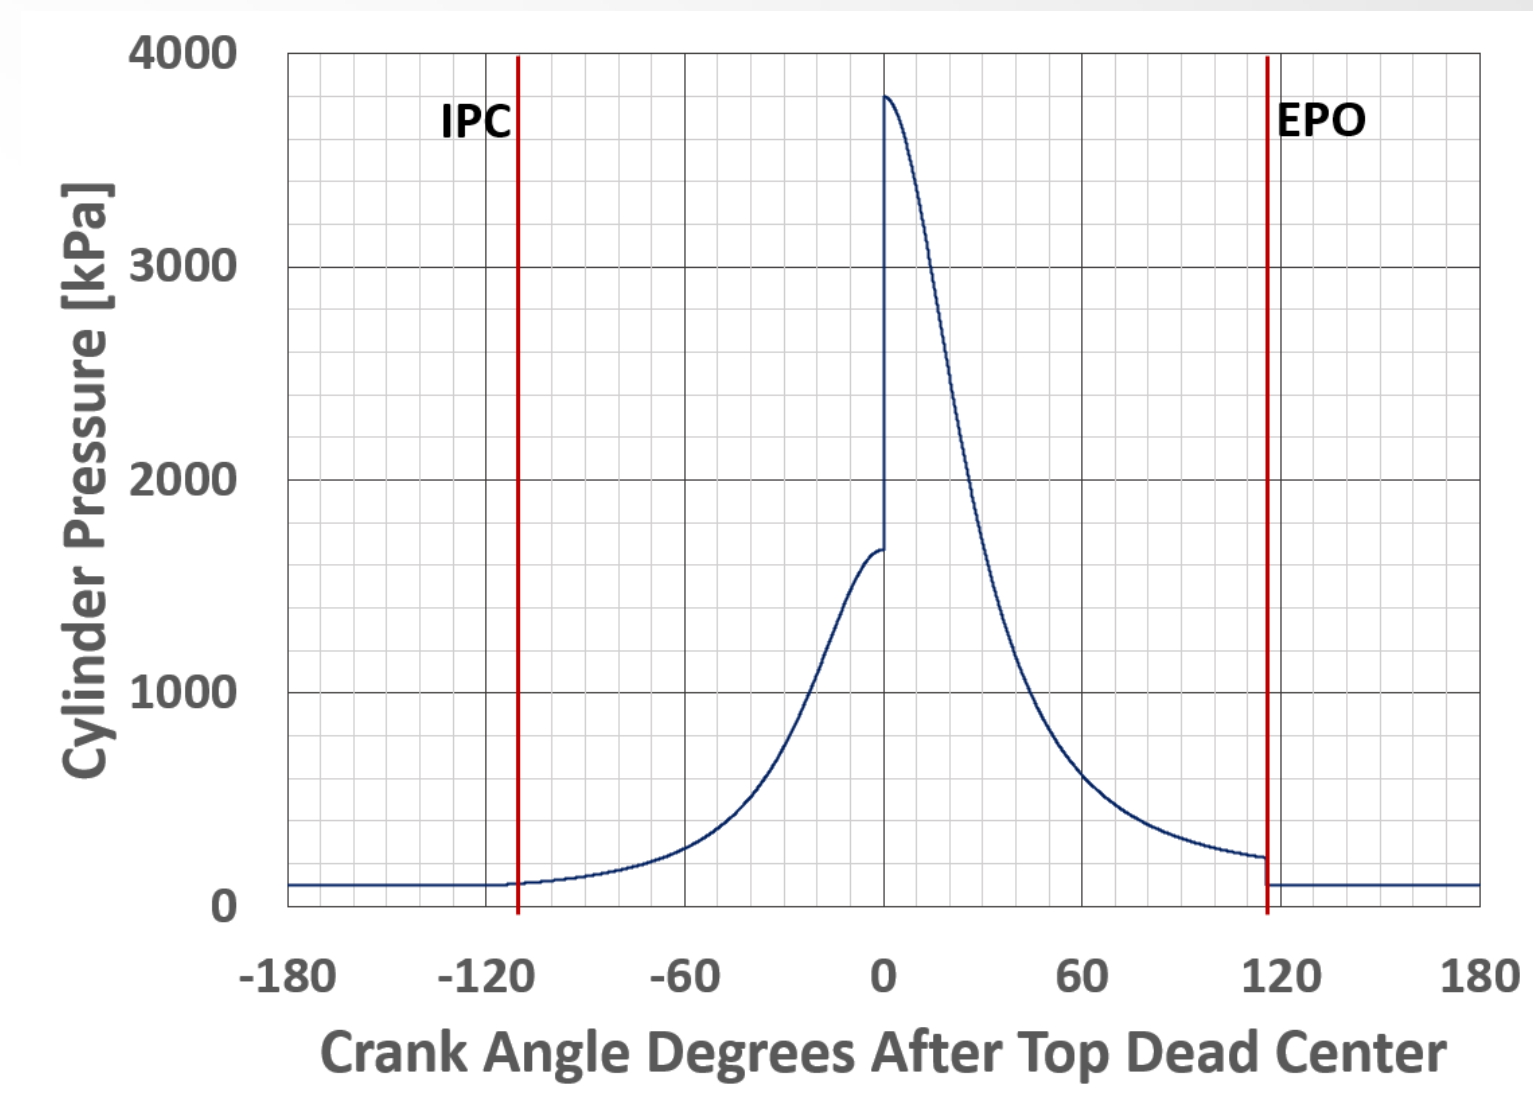
- **Multi-cylinder time domain model**
 - The engine model is built on a simplified crankangle based cylinder model
 - The cylinder model is based on the polytropic process with an instantaneous heat release at TDC
 - The heat release was tuned to match the measured engine acceleration during normal starting events

Bore	130	mm
Stroke	135	mm
Conrod Length	226	mm
Clearance Volume	0.18	liters
Inlet Port Closure	115.4	deg BTDC
Exhaust Port Opening	115.4	deg ATDC
Polytropic Exponent	1.3	-
Peak Cylinder Pressure	38	bar

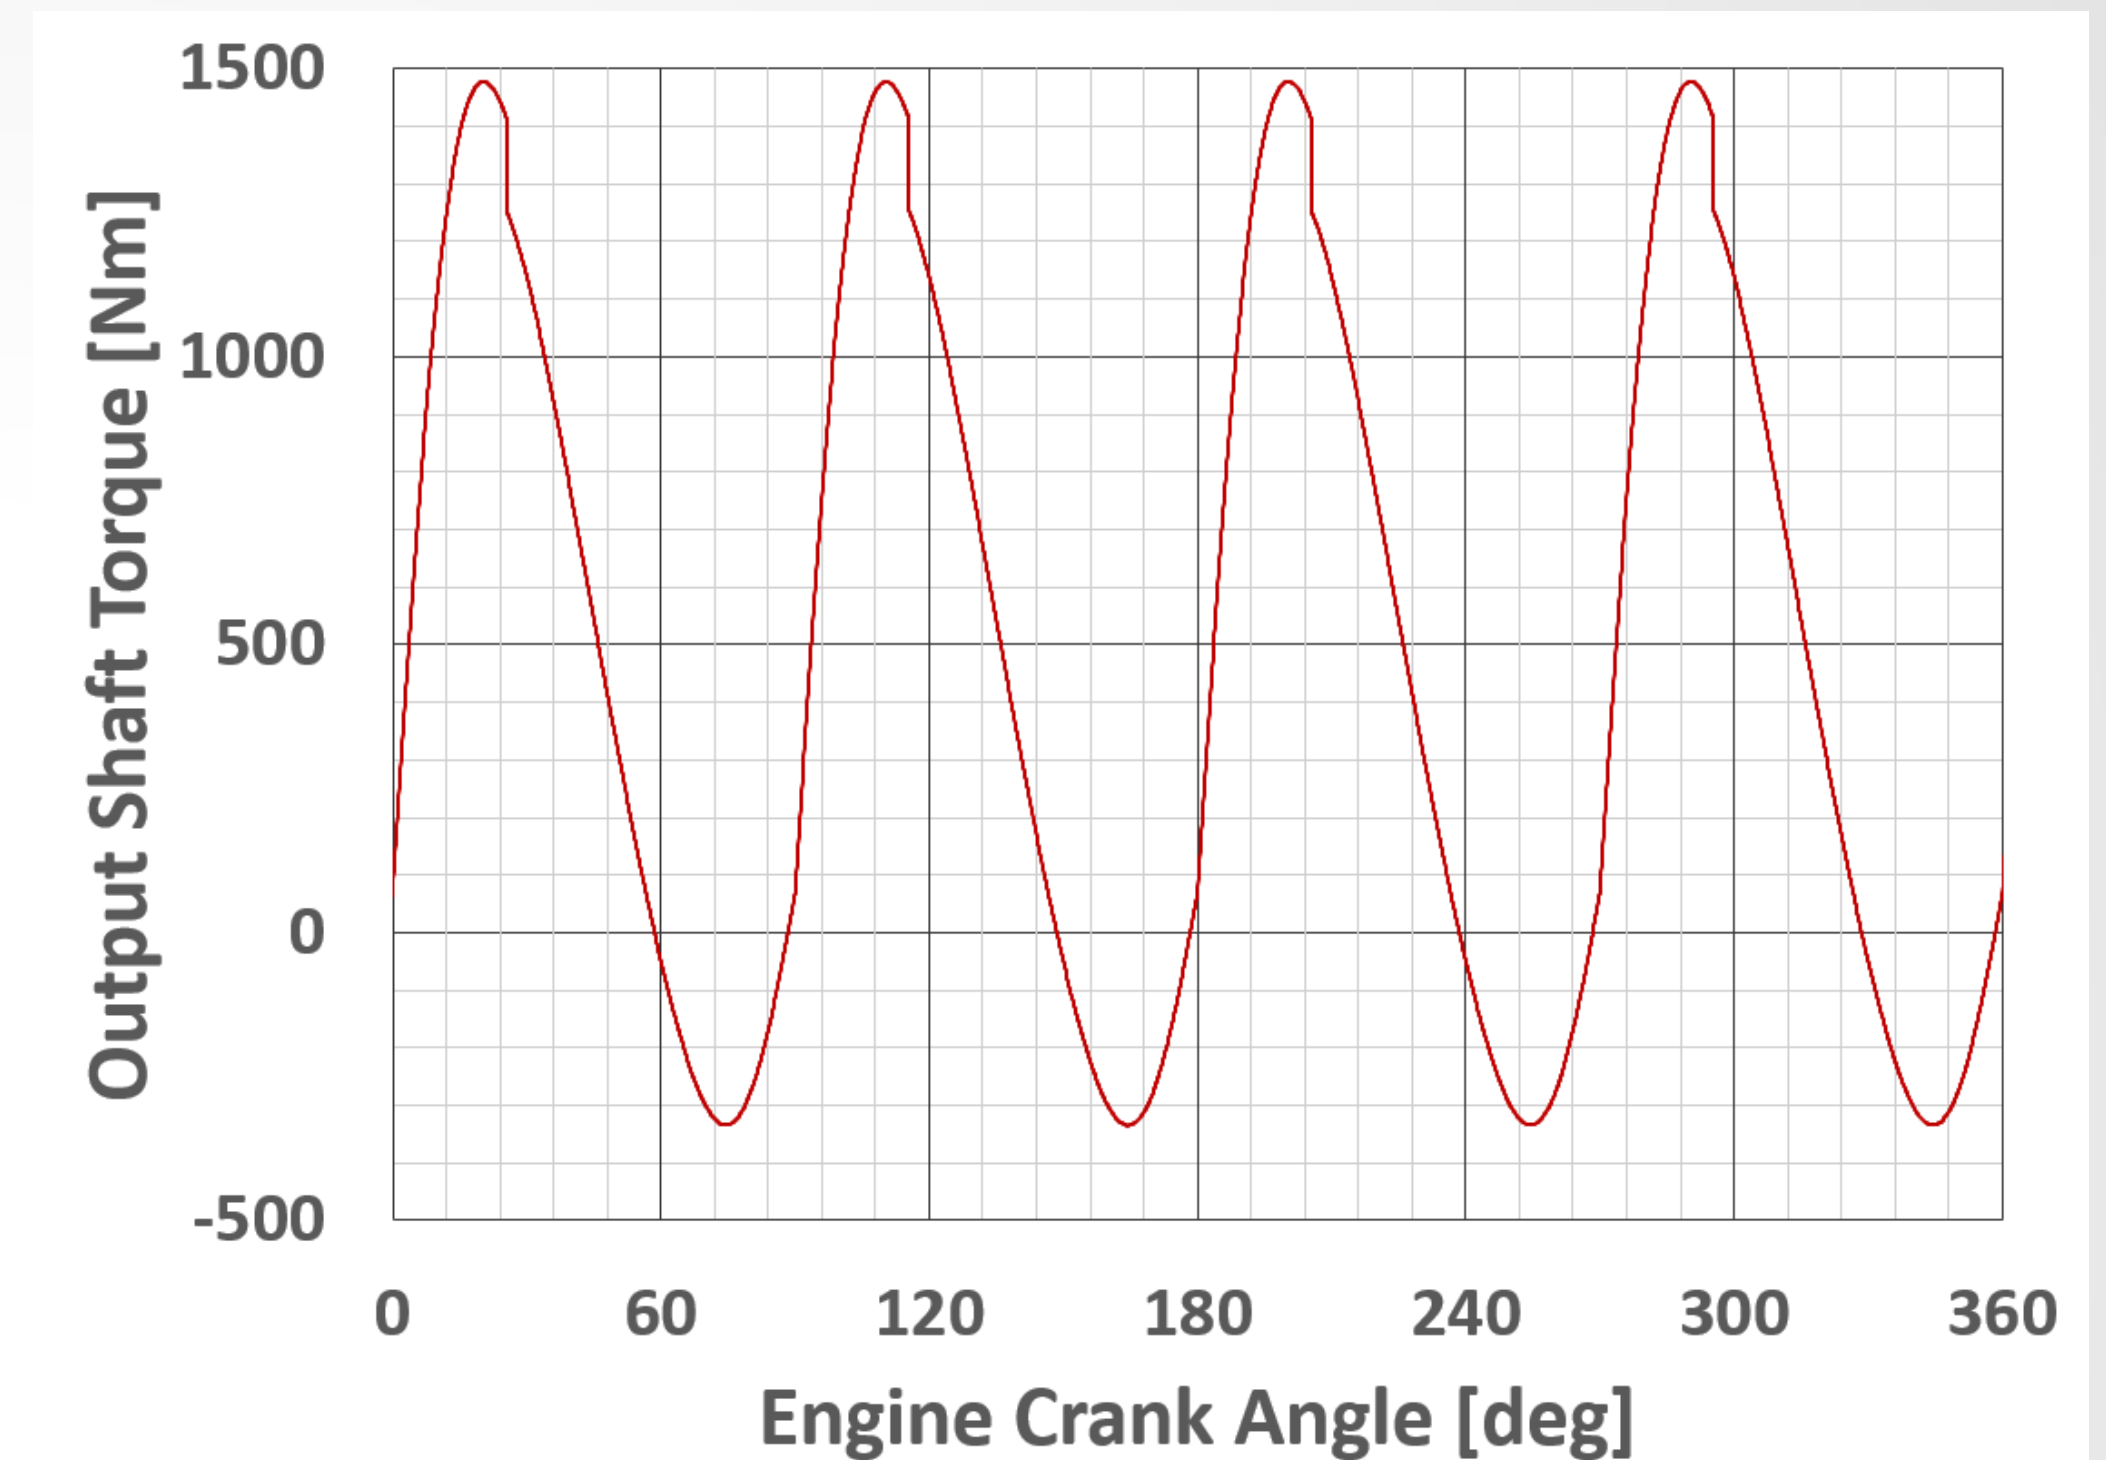
Four Cylinder Engine Torque Trace

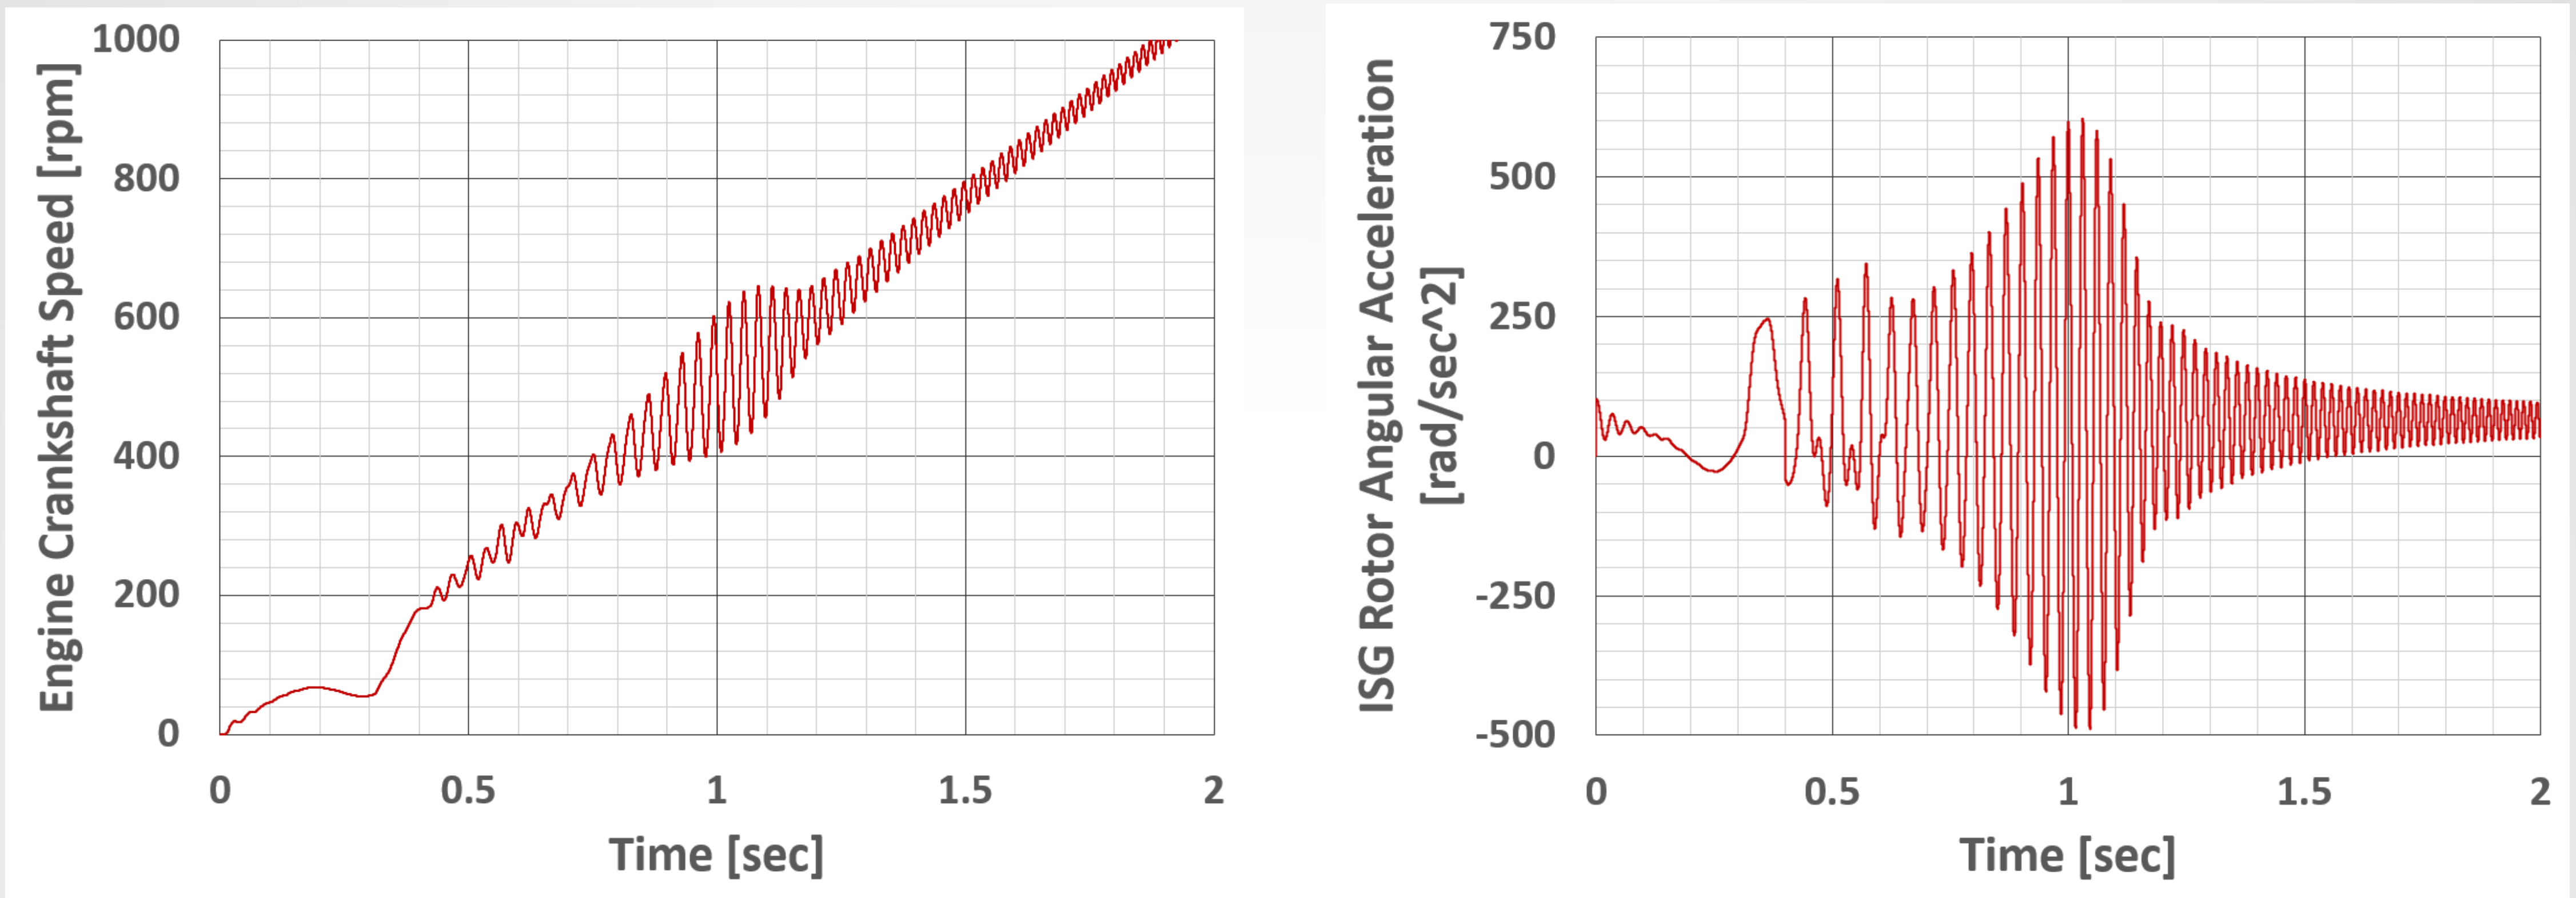
Time Domain Model Results – Normal Engine Start

- Model predicts peak ISG rotor acceleration of 600 rad/s^2
 - Results in 2000 Nm reaction torque when applied to a rotor inertia of 3.3 kg-m^2
- 21 cycles in excess of 250 rad/s^2

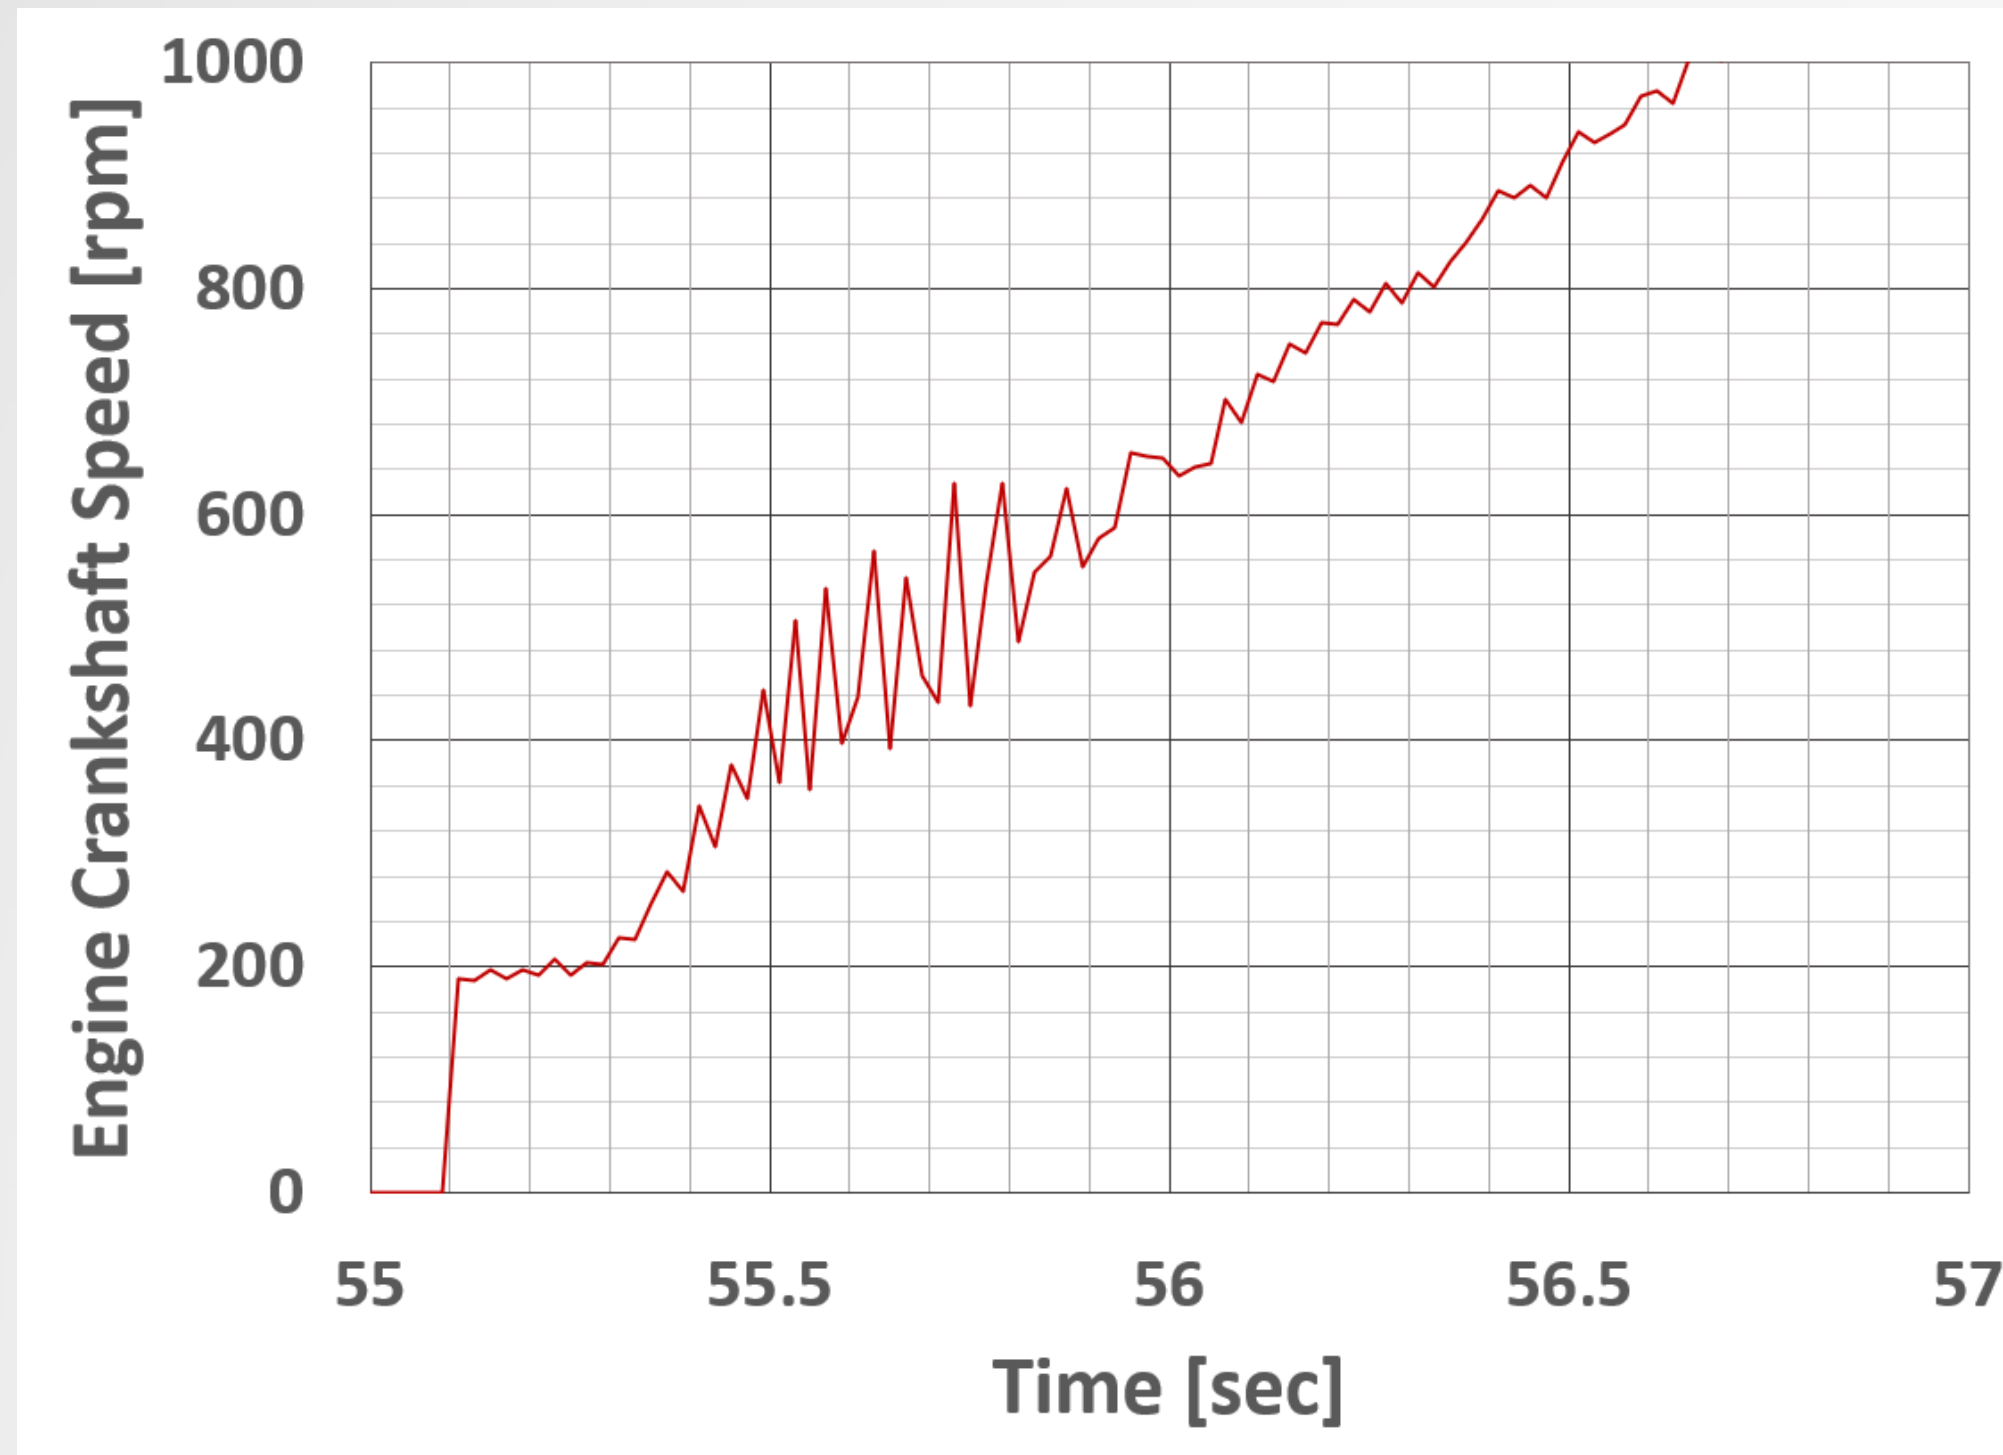
Actual ECU CAN Data
