A Case Study of an ISG Failure Using a Time Domain TVA

John Srodawa

Failure Description

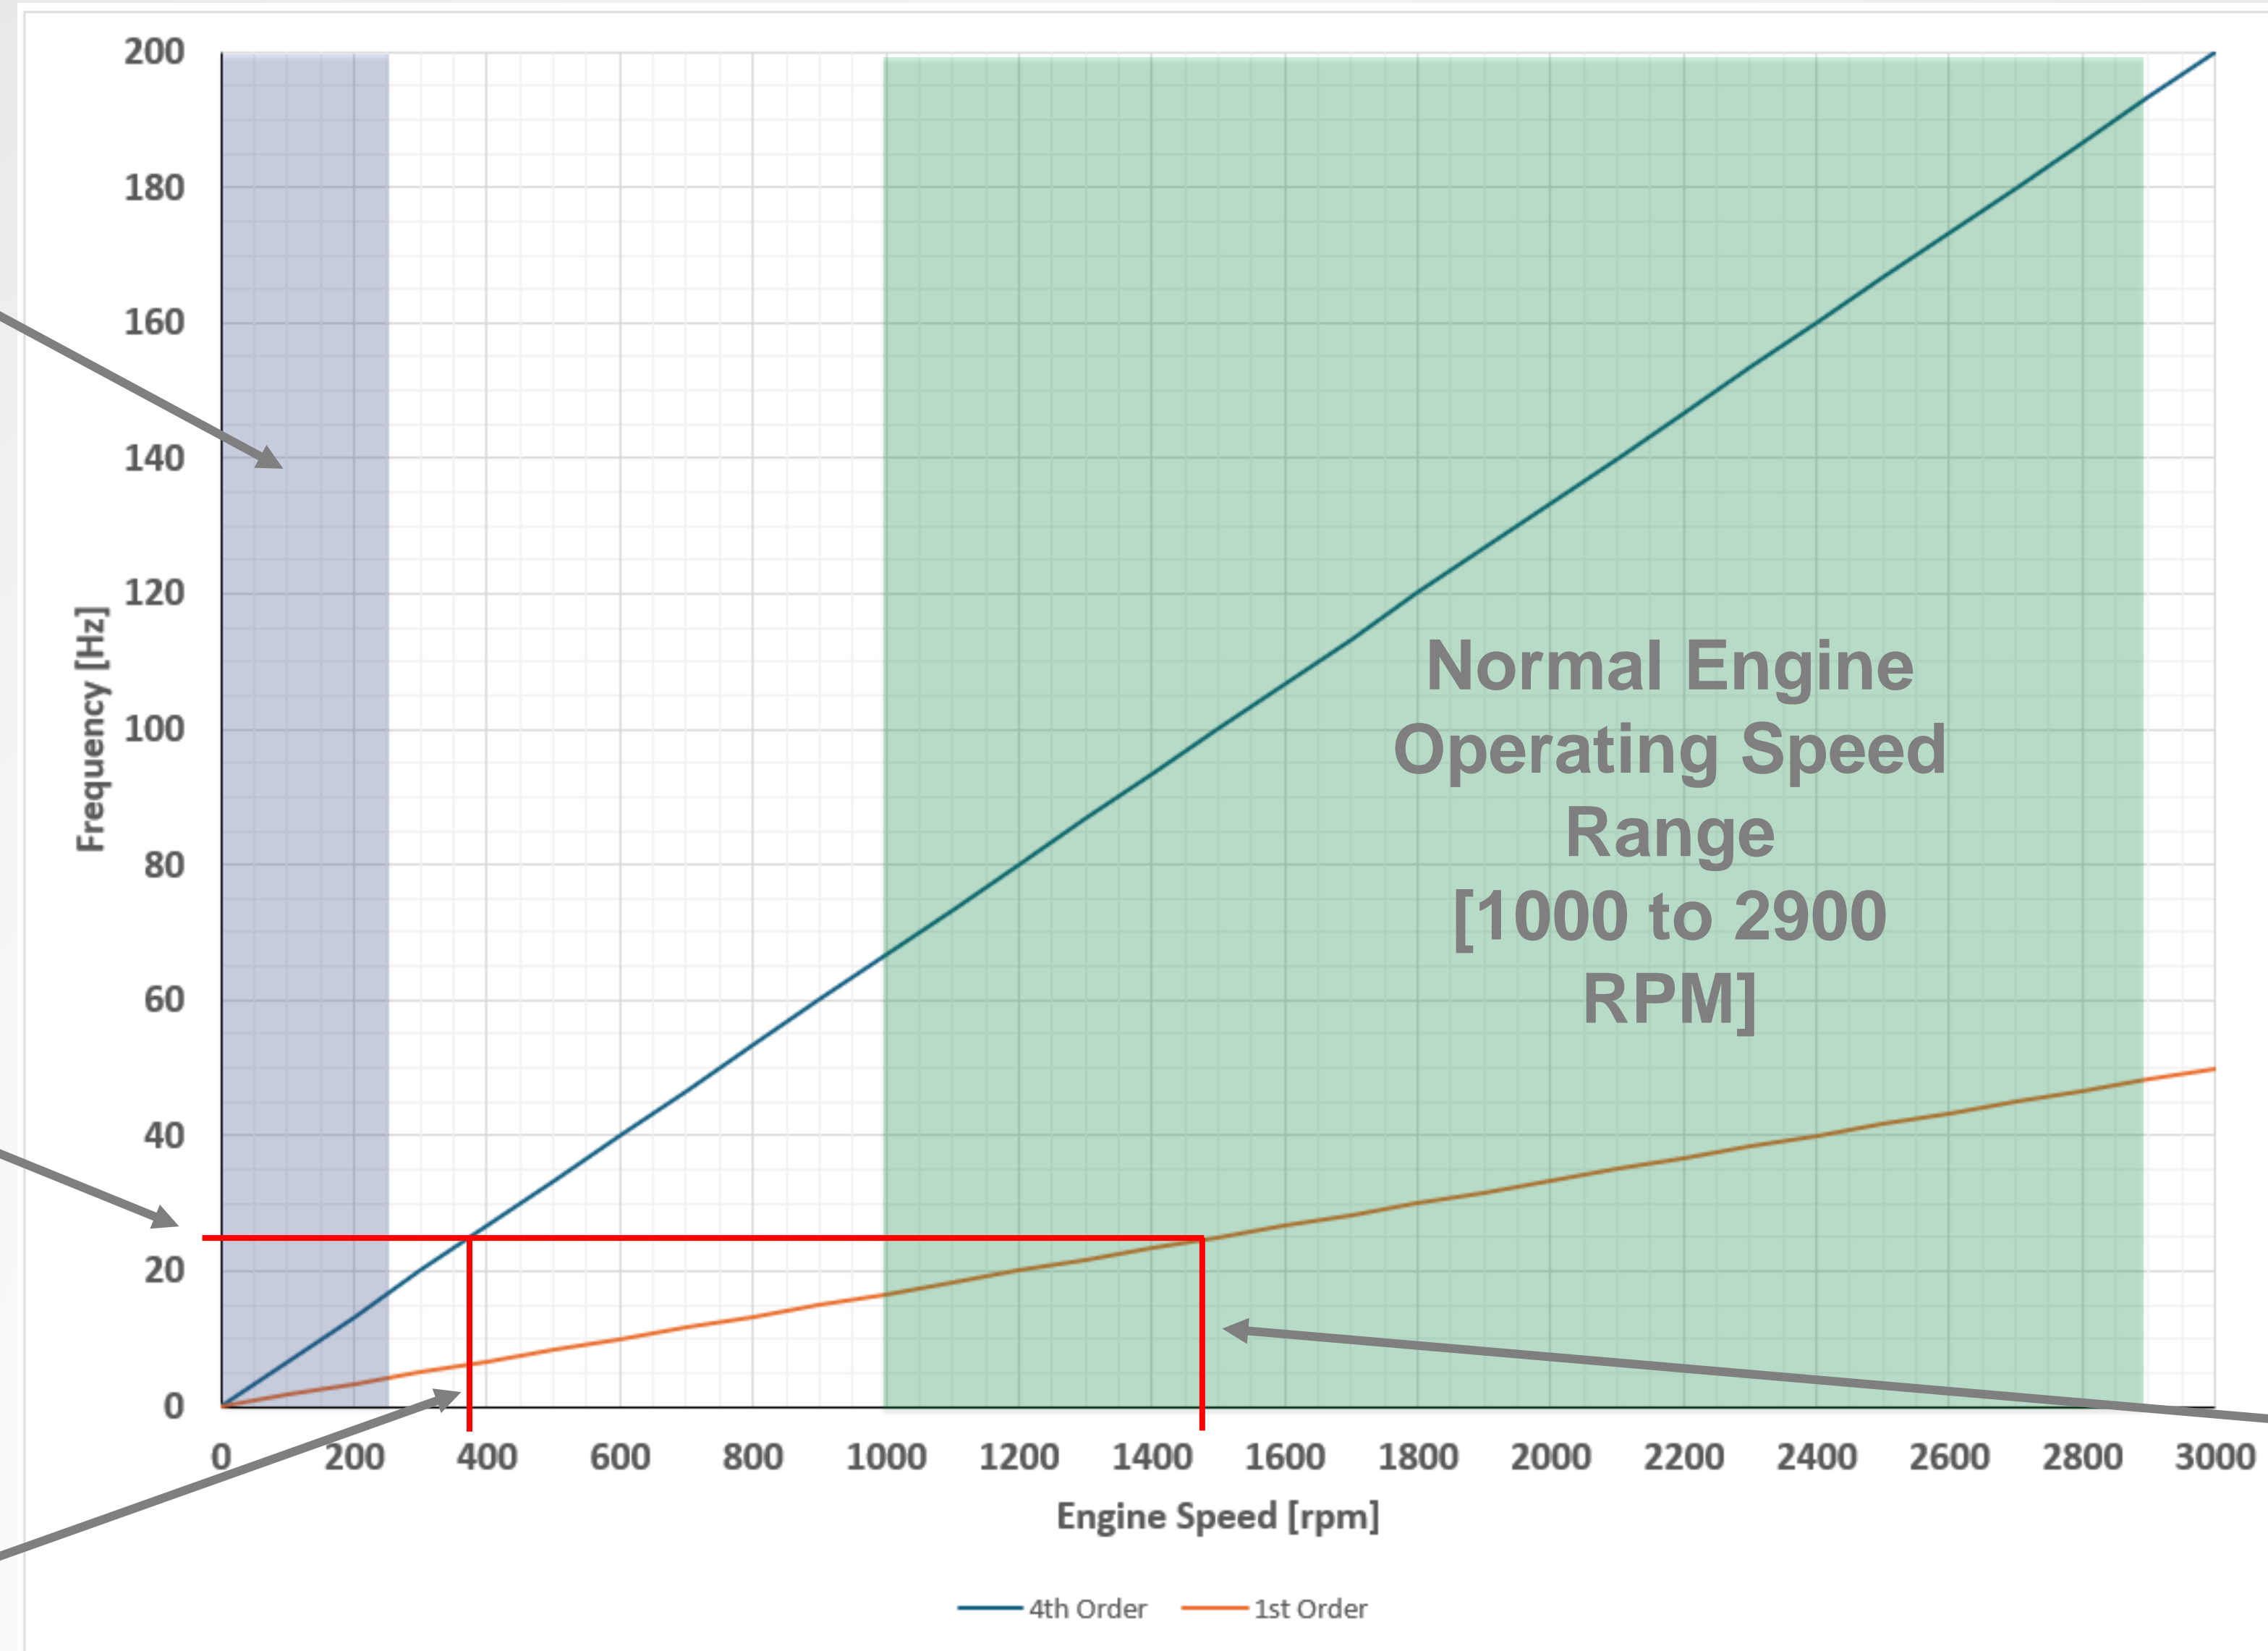
Don't Forget About Engine Misfire

Engine Cranking Speed Range [0 to 250 RPM]

Design Natural Frequency [26Hz]

4th Order Resonance [390 RPM]

1st Order Resonance [1460 RPM]
